**KoNaR**  
**CAN** INTO SPACE

Team 2050 – KoNaR Can

# Post Flight Review (PFR)

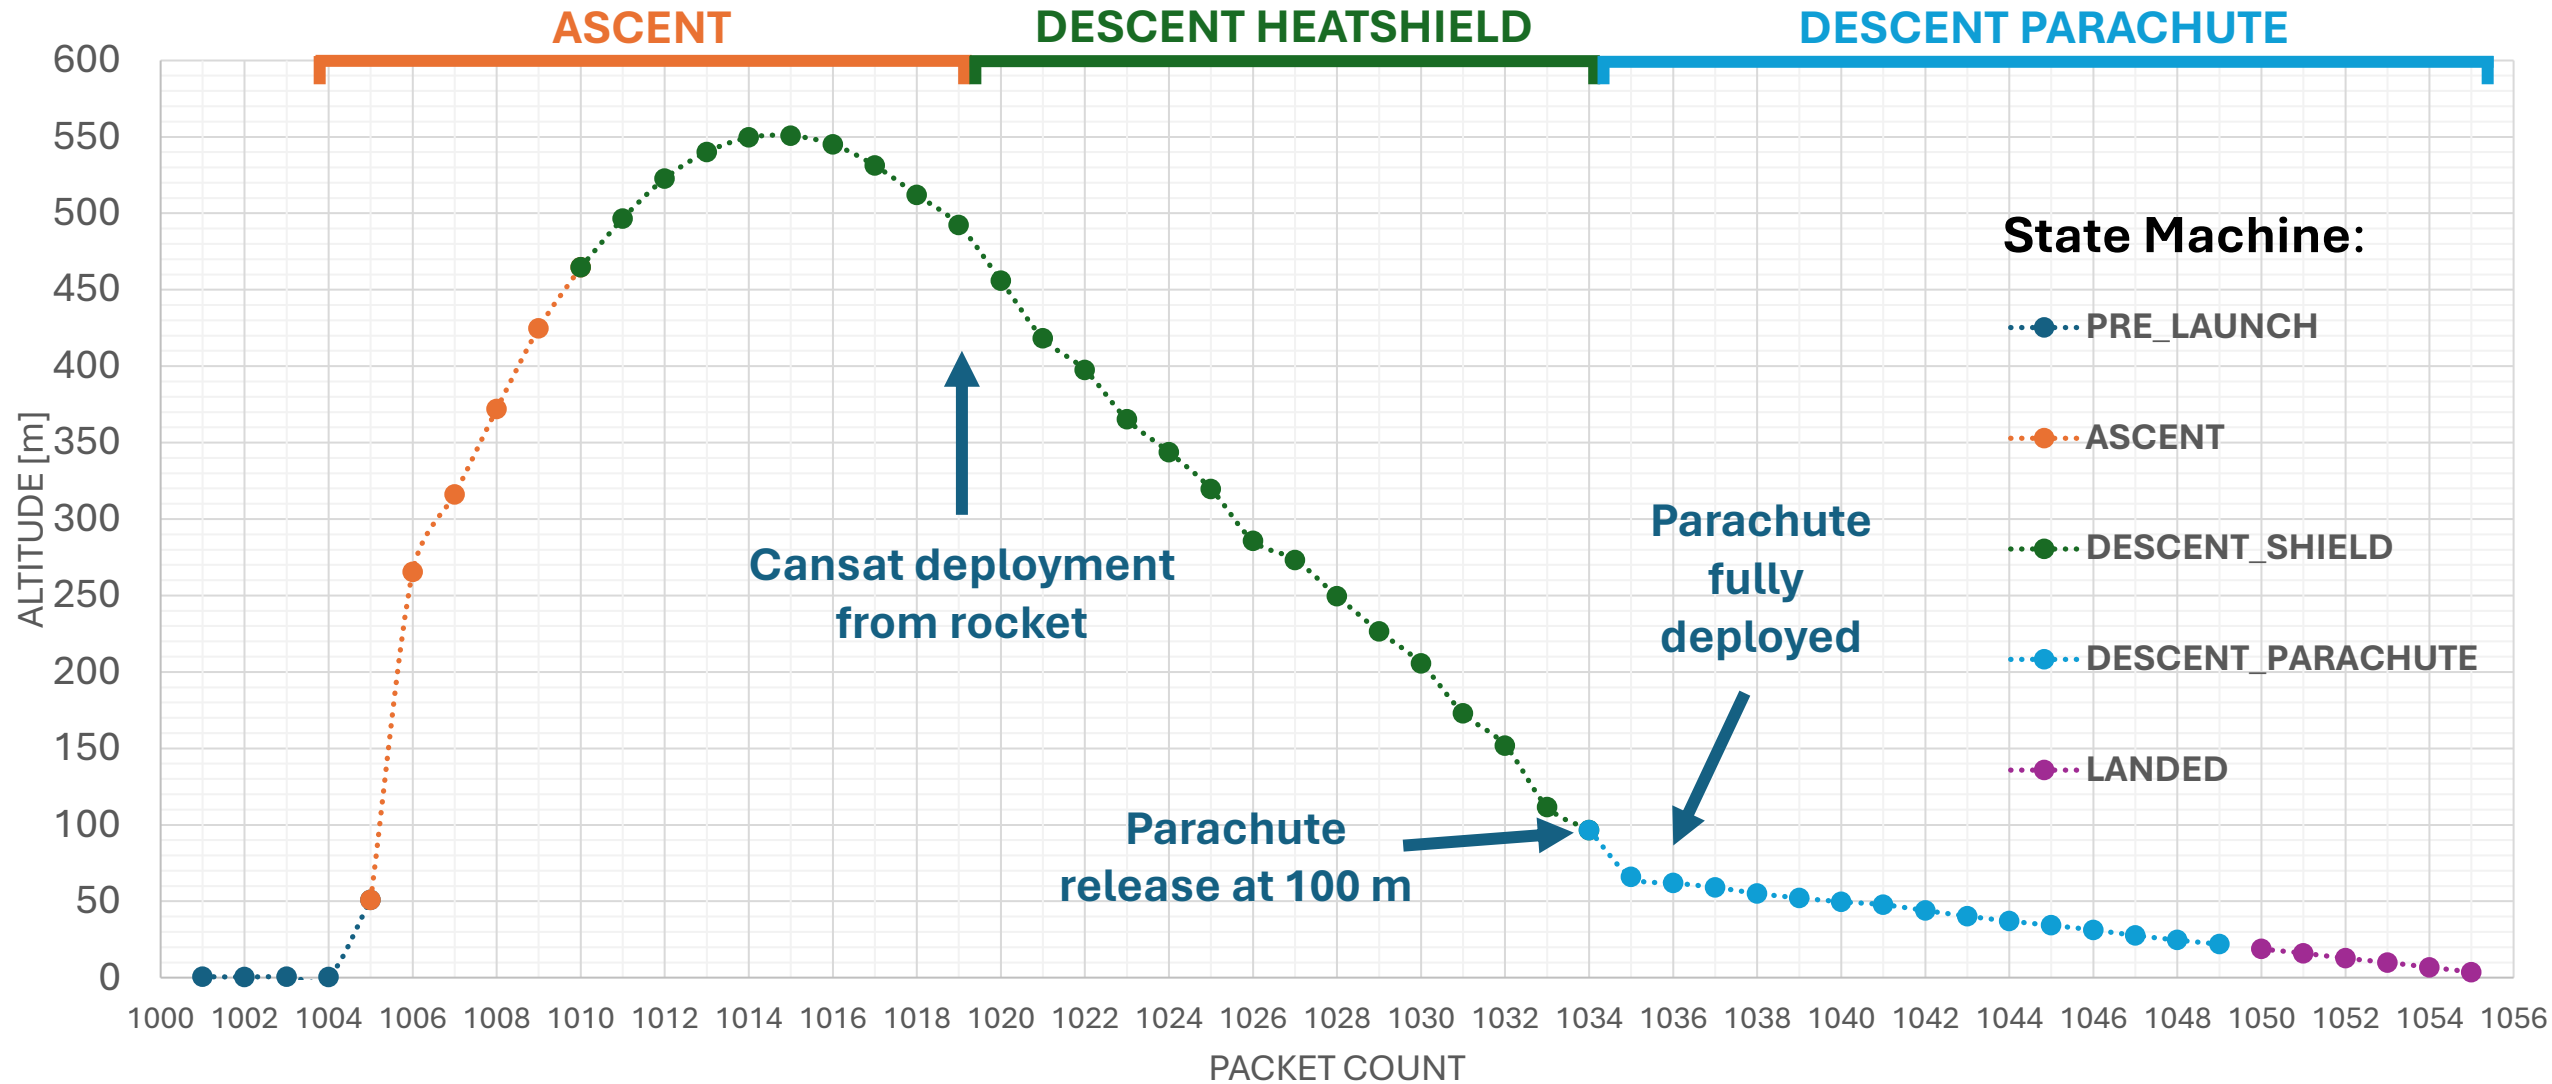
# Payload altitude plot

The CanSat state machine switched its state during ascent earlier than expected.

The maximum altitude was lower by 150 meters than anticipated.

- Large pressure fluctuations during ascent;
- Too loose state change conditions.

- More tests with noisy data;
- Reduce the frequency of checking the altitude condition.

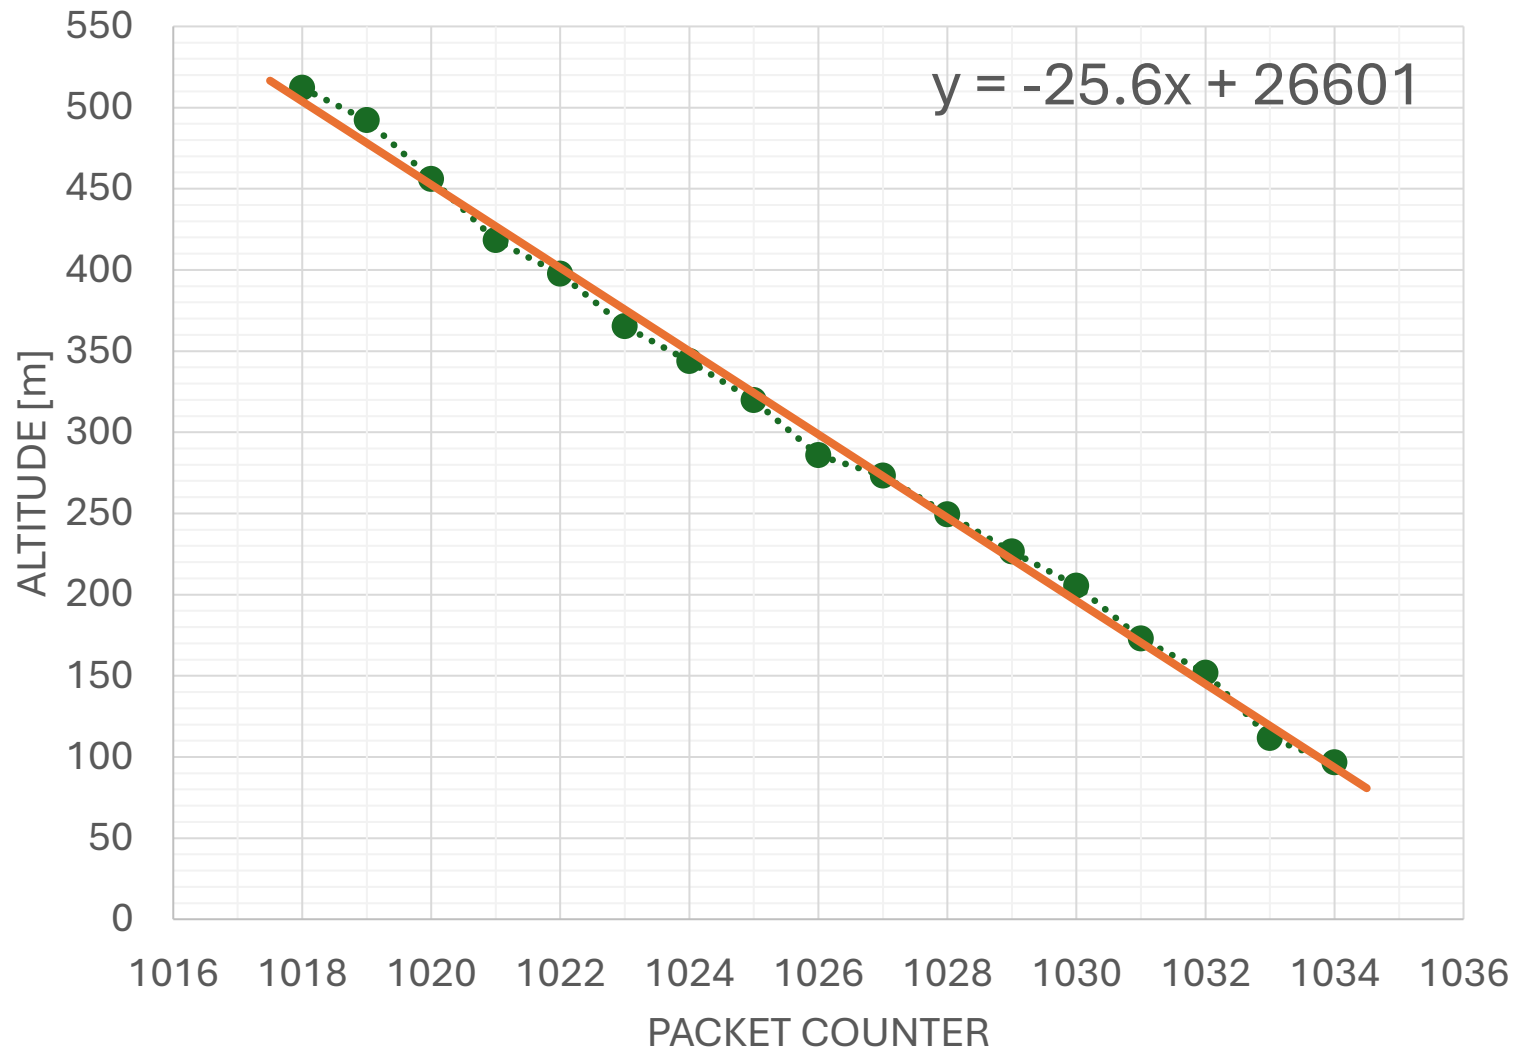
# Aerobreaking Descent Rate Plot

The aerobraking speed calculated from altitude change over time is about **25.6 m/s**.

This value was acquired using the linear regression plot function in Microsoft Excel.

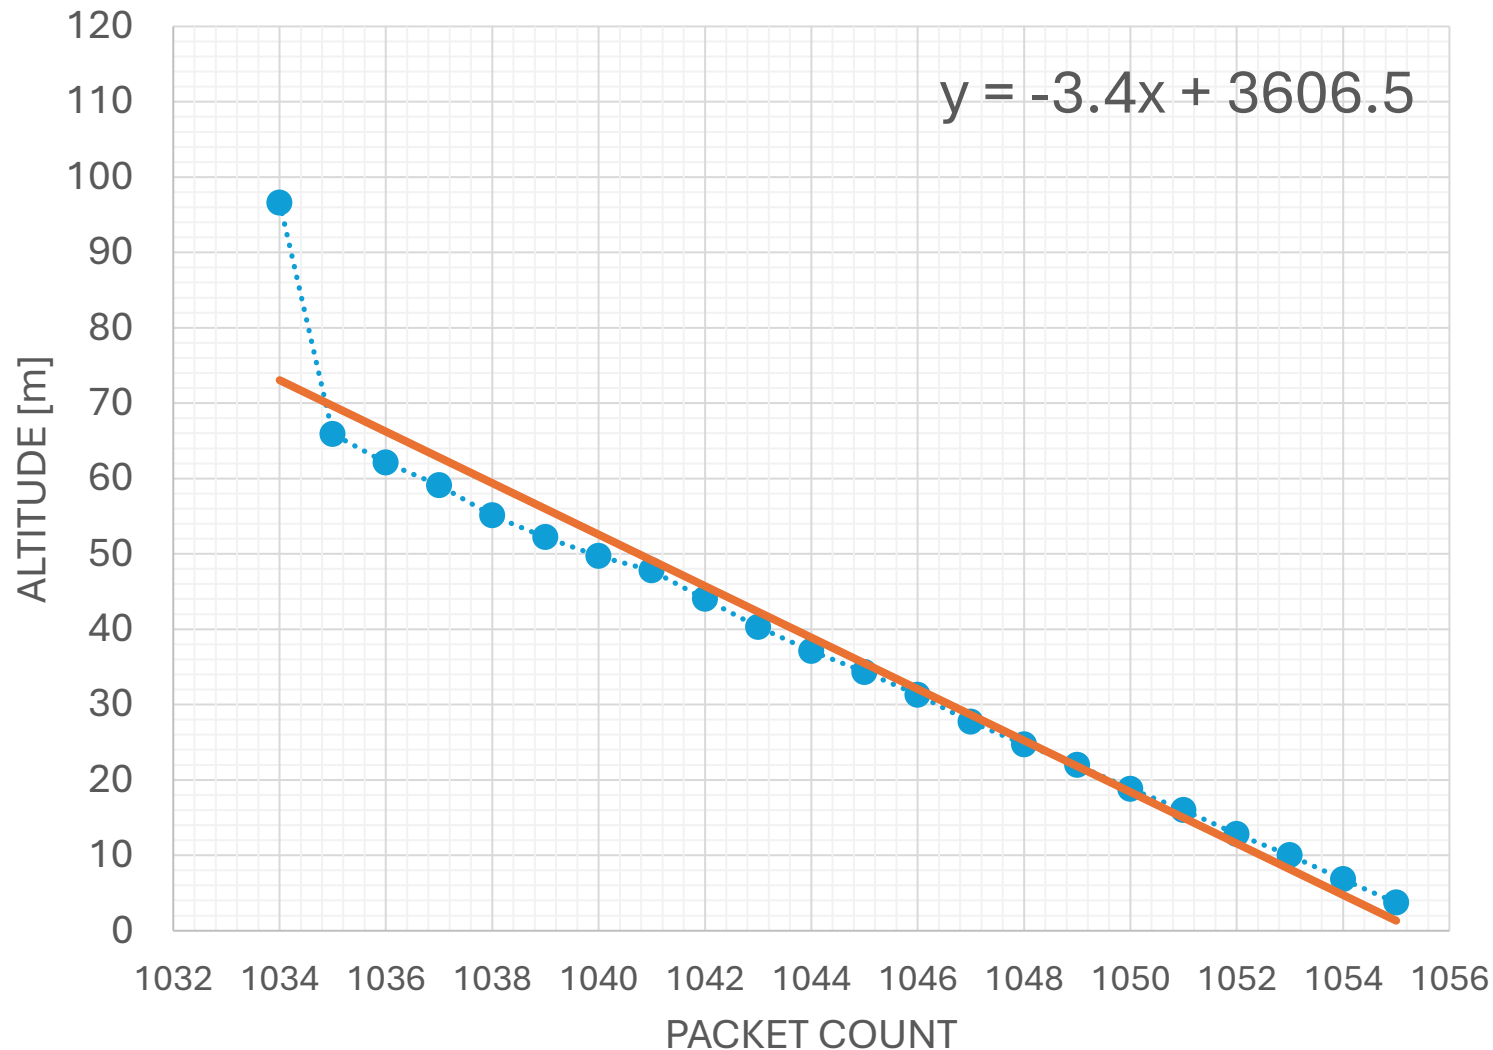
# Parachute Descent Rate Plot

The parachute descending speed calculated from altitude change over time is about **3.4 m/s**.

This value was acquired using the linear regression plot function in Microsoft Excel.

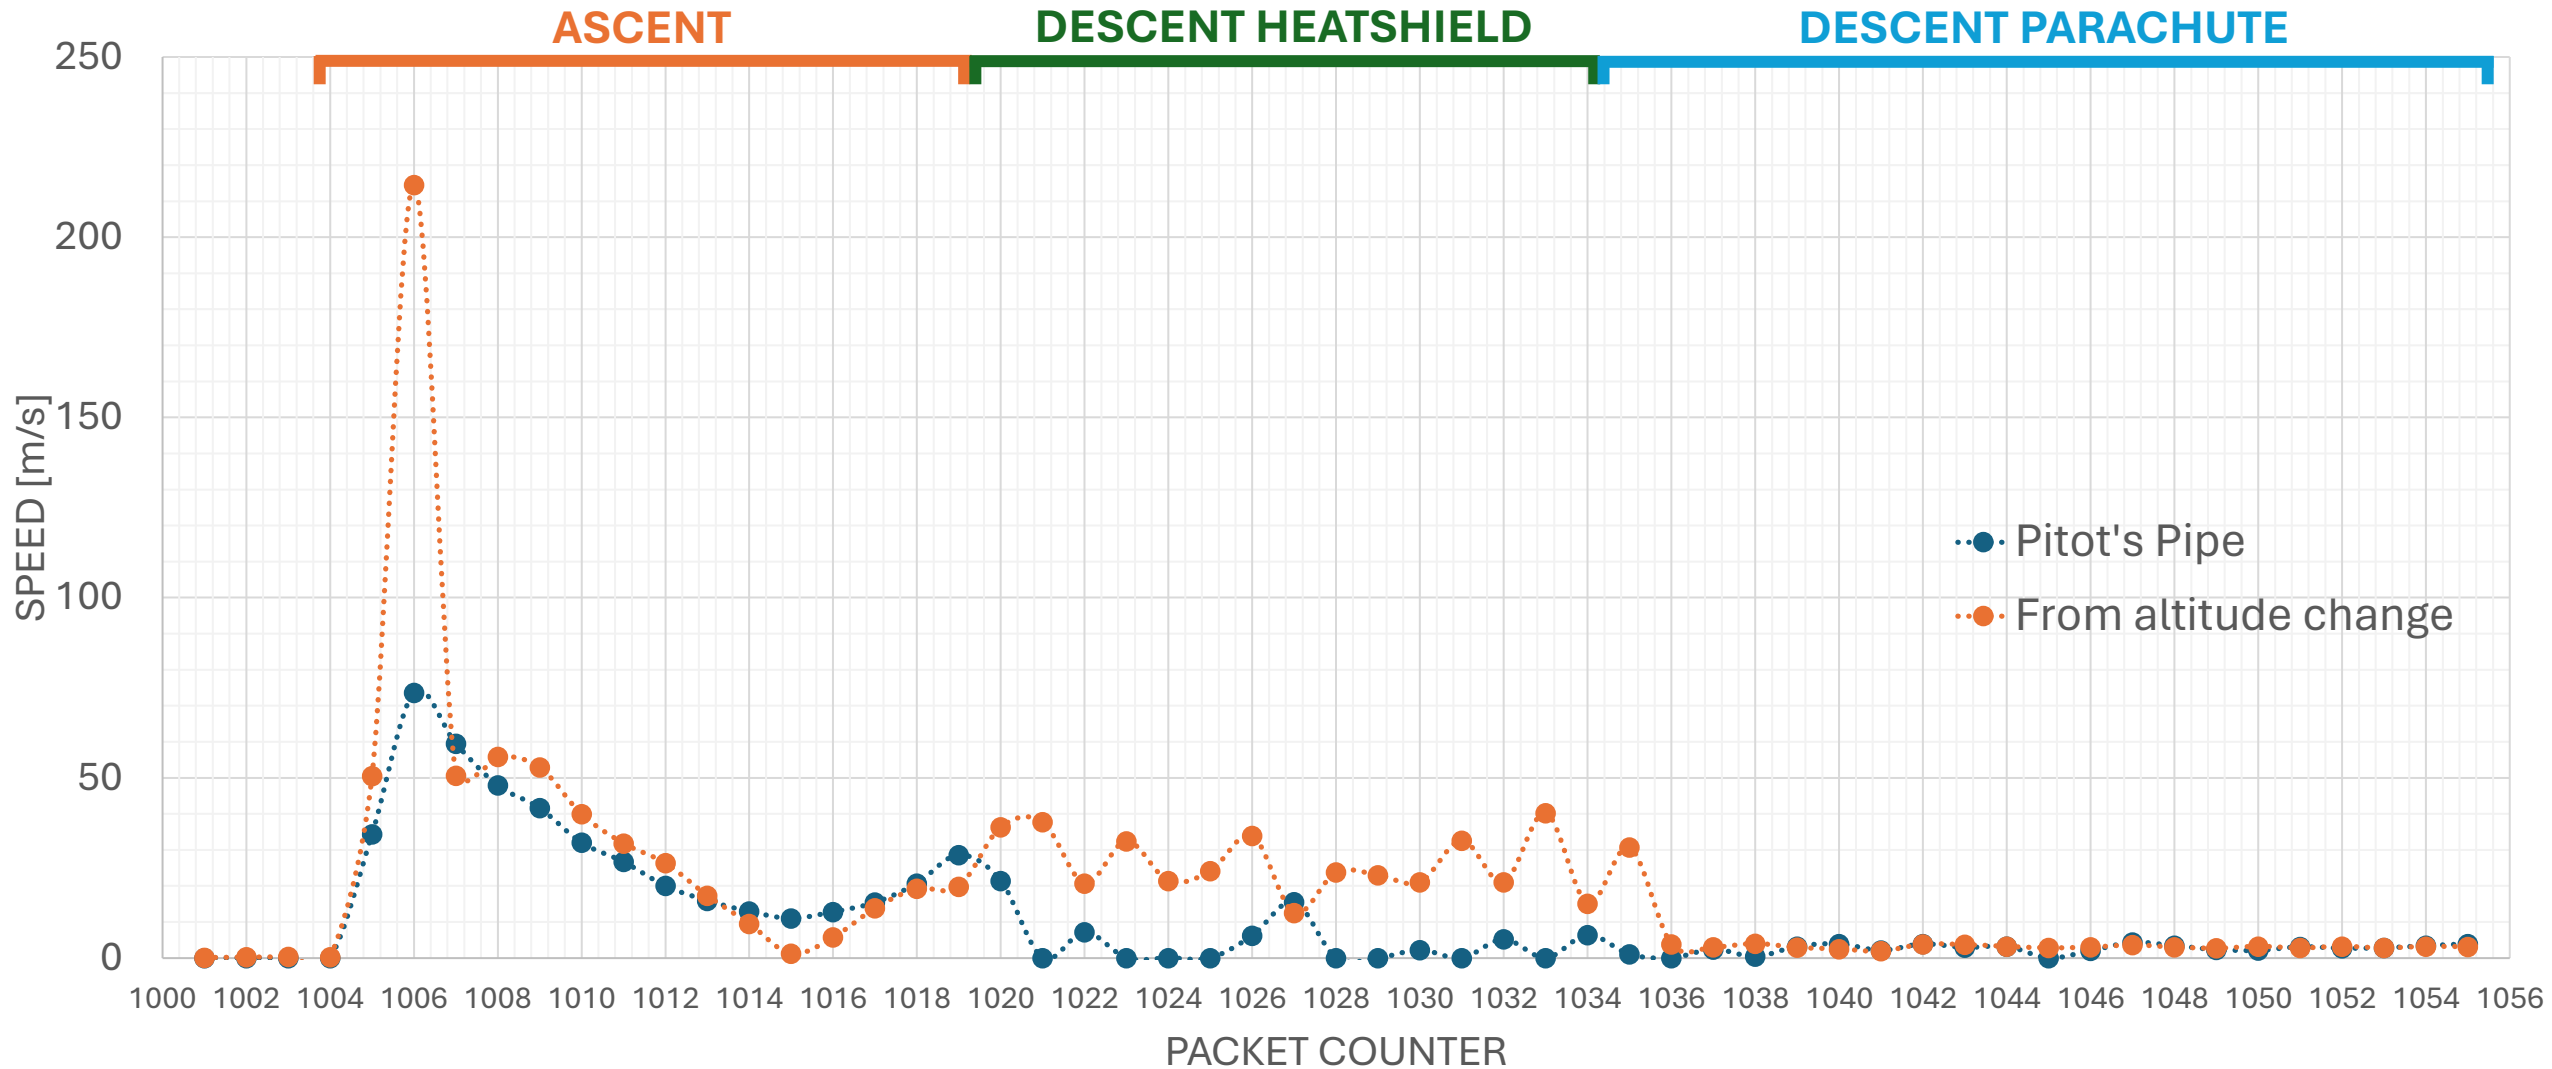
# Pitot's Pipe Speed Plot

Tumbling after CanSat deployment led to a problem with the descending speed measurement using Pitot's pipe.

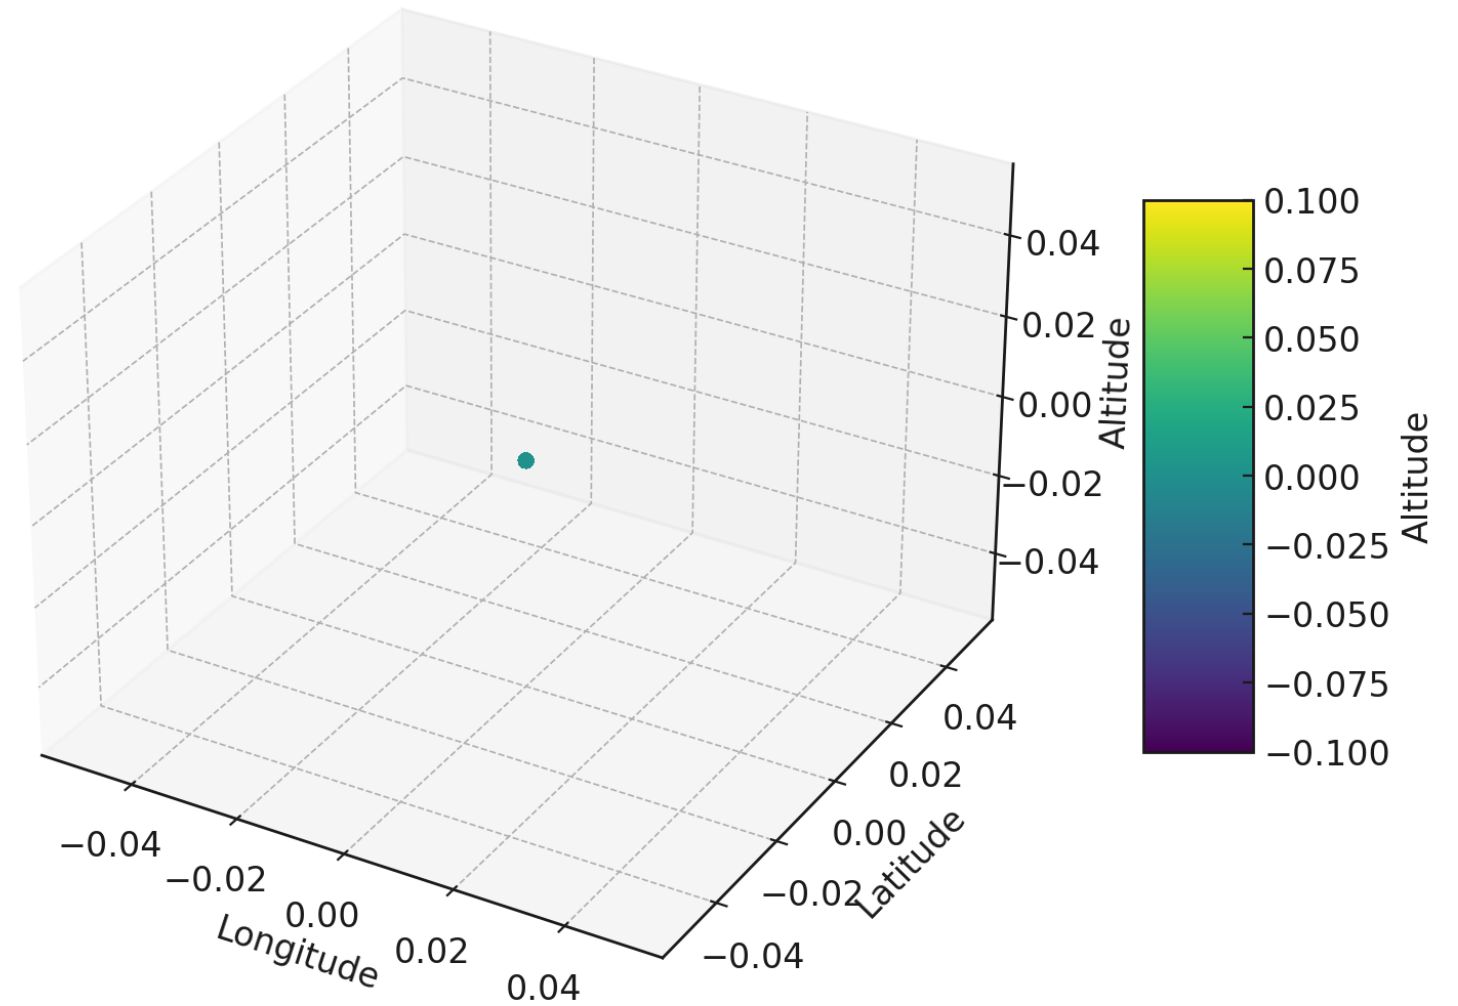
# Payload GPS position plot

Non-functional GPS module

- Insufficient GPS tests;
- Acquiring a Fix Point proved to be challenging at the flight location.

- Conduct more tests of the GPS module in various atmospheric and topographical environments to ensure reliability and accuracy;
- Acquire a better GPS module;
- Perform preliminary tests in the launch side area to verify its performance before the main flight.
