**KoNaR**  
**CAN** INTO SPACE

Team 2050 – KoNaR Can

# Post Flight Review (PFR)

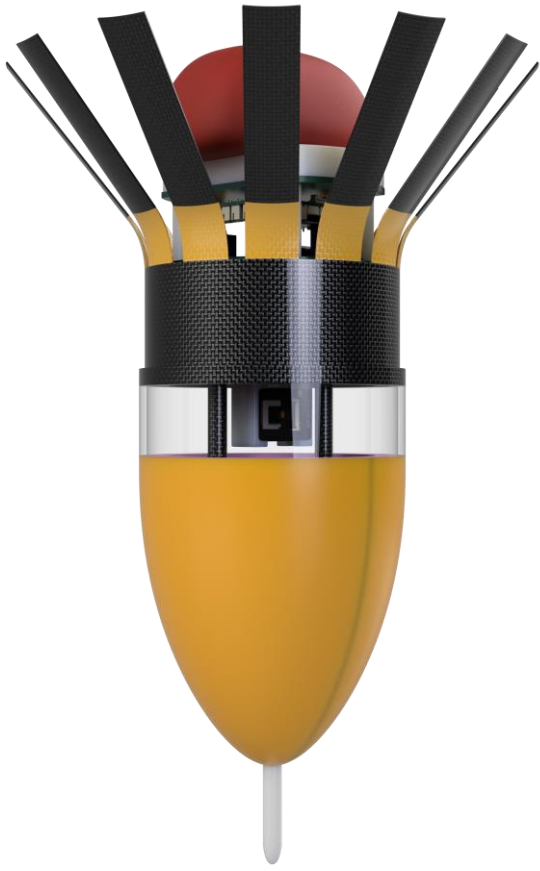
CDR Design

In the last stage of work on our CanSat, the following problems appeared:

- Too much weight
- Too tight fit in the rocket
- Problems with carbon fibre manufacturing
- Procurements problems

Unfortunately, we had to change the heatshield design to solve them.

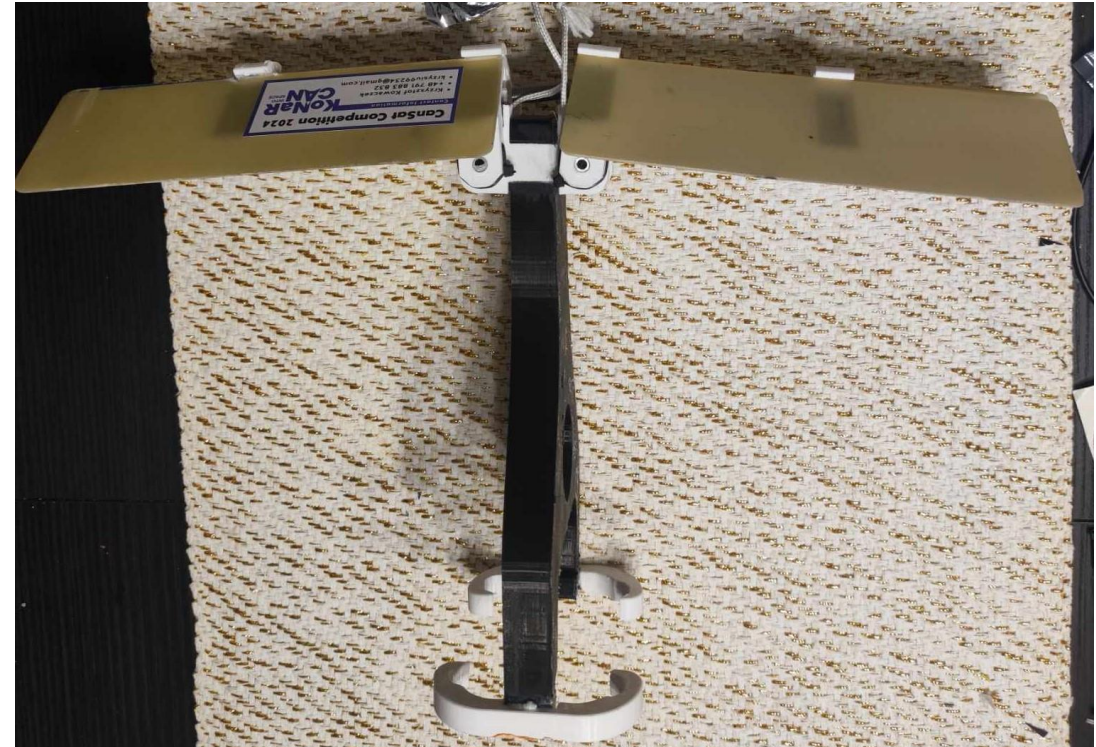
Deployed  
configuration

Trouble with aerobrake structural integrity led to aileron loss and a slightly faster descent than anticipated (but still in acceptable range).

Manufacturing error led to insufficient structural strength of the ailerons

- Manufacturing error led to insufficient strength of one of 3D printed parts and its failure

- Conduct more tests of manufactured parts with more strict passing conditions.
